**Geoarchaeological Study on
Rock Art Sites,
With Special Emphasis on
Gabel-El-Silsilah and Wadi Hammamat**

Geoarchaeological Study on Rock Art Sites With Special Emphasis on Gabel-El-Silsilah and Wadi Hammamat

Abstract

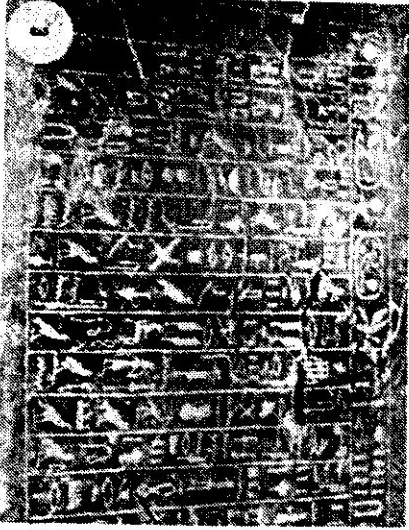
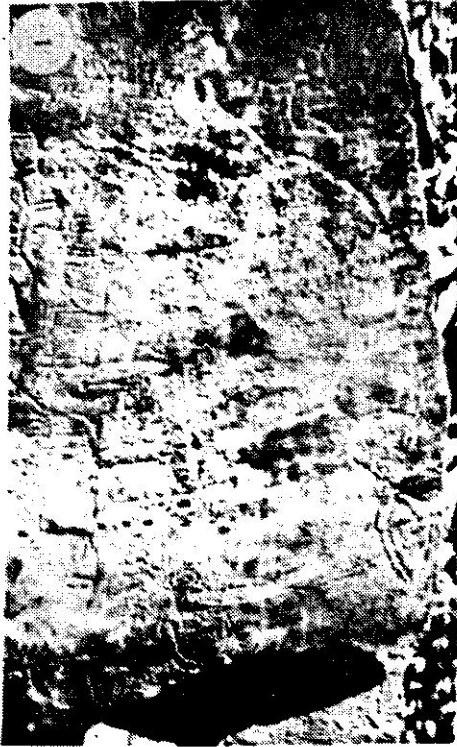
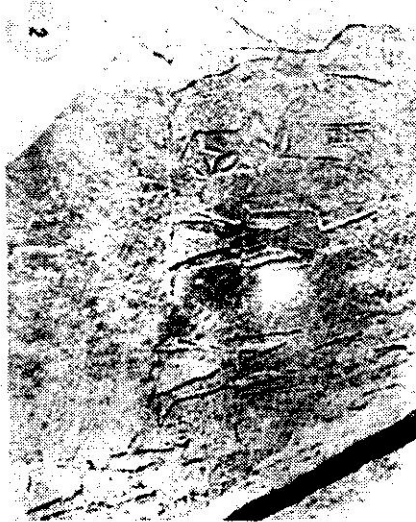
**Fig. (3) : Shows a text dates back to Amenemhat III carved
in Greywacke.**

**Fig. (4) : Shows inscription of Ramses II carved directly in
metasediments.**

These carvings suffer severely three types of weathering. The first is the physical weathering in which temperature, stress, frost damage, and wind action play the major role in their deterioration. The second type is the chemical weathering through which the feldspar minerals transform into clay minerals. Water that penetrates through the rock cracks is prerequisite for the chemical process. This in the long run, leads to leaching out of material with new weathering factors in consequence. The third is the biological attack such as plants, algae and lichens, which lead slowly to the destruction of minerals. Besides contributing to the change in the moisture content, the plants produce some organic acids, which dissolve certain minerals. They also have the ability to grow into cavities and causes cracking as well as they lift small parts of the stone by swelling. (Pl. 1, Figs. 3, 4) show examples of carvings directly in bed rock.

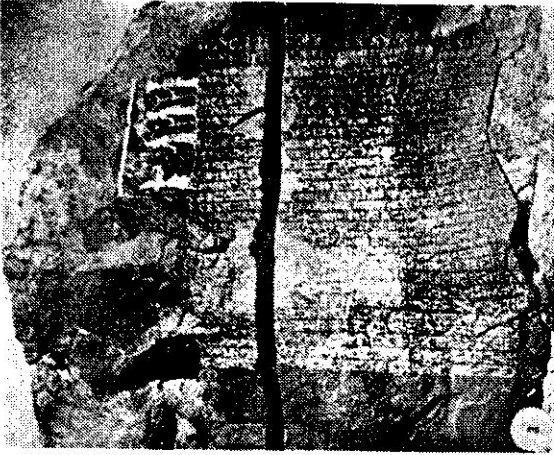
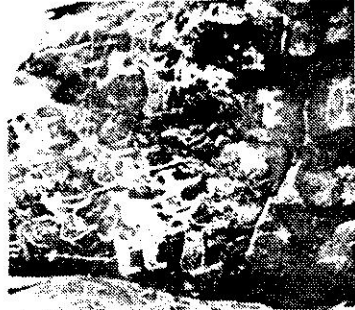
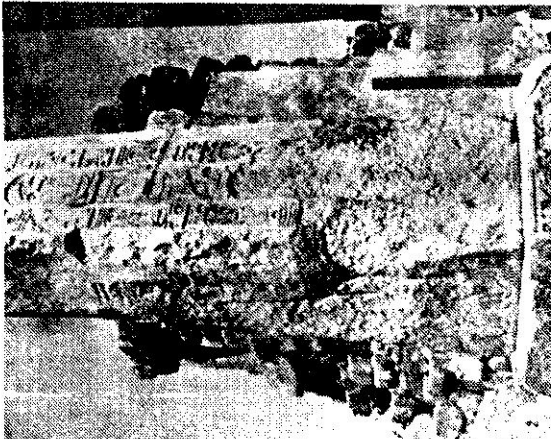
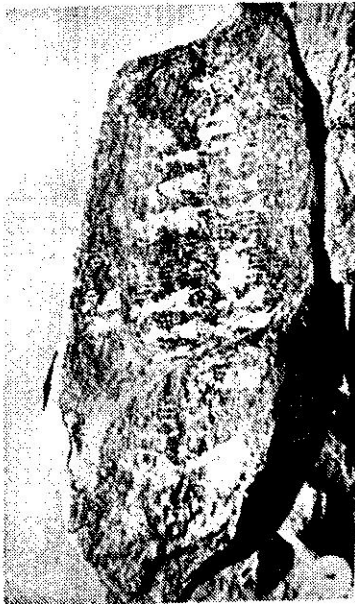
Pl. 2

- Fig. (1) : Hatchepsut obslisk with inscriptions carved on Granitic stone, Karnak Temple.**
- Fig. (2) : Surficial exfoliation presenting in Hatshpsut Granitic obelisks at Karnak Temple.**
- Fig. (3) : Stele of famine carved in Granitic stone, Siheyl island, in Aswan.**
- Fig. (4) : Rock carving in Granite showing flaking of surface layer, Siheyl island, in Aswan.**
- Fig. (5) : Graffiti in Granitic stone showing the flaking of surface layer.**

Obelisks are considered one of the rock art types that are associated with heroic deeds during the different dynasties of ancient Egypt. Records were inscribed on their granite surface as hieroglyphs in their vertical rows about 1.5 inches deep (Pl. 2, Fig. 1). The history of these obelisks started as the time of Queen Hatchepsut of the 18th dynasty, her brother Thotmos III who had the center rows erased later Hatchepsut's name inscribed. Ramses II added the outer two rows on each face with his own name and his achievements. This present work tries to identify the durability that affects the granite obelisks in Egypt. So, it is clear that these obelisks suffer from chemical weathering. These obelisks suffer from physical and chemical weathering. The color of granite was changed to pale rose or gray while biotite was altered to pale yellowish brown (Pl. 2, Fig. 2). The surface layer was cracked and Flakes into Falls (Pl. 2, Fig. 2).

The most important deterioration phenomena in granite are the exfoliation patterns. Granite crusts resulted from that exfoliation is friable when it is thin, while thick crusts is quite hard. Owing to the tremendous environmental factors by physical and chemical weathering (Pl. 2, Figs. 2, 3, 4).

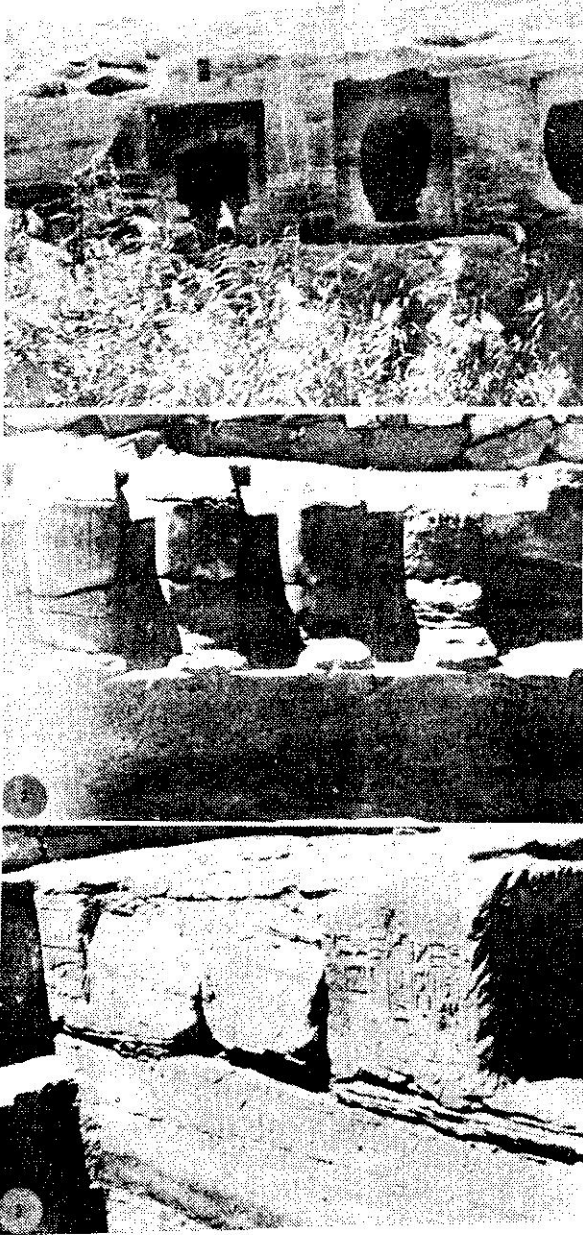
Pl. 6

- Fig. (1) :** The deterioration of stone of different chapels due to the effect of moisture which led to the dissolution of some mineral constituents such as Ferric oxides and Clay minerals with the destruction of chapel facades.
- Fig. (2) :** The lower parts seriously deteriorated by the accumulation of micro-organisms with salt efflorescences. Also badly preserved statues can be observed.
- Fig. (3) :** The deterioration of the mineral constituents of stone due to the effect of the Physio-Chemical Factors.

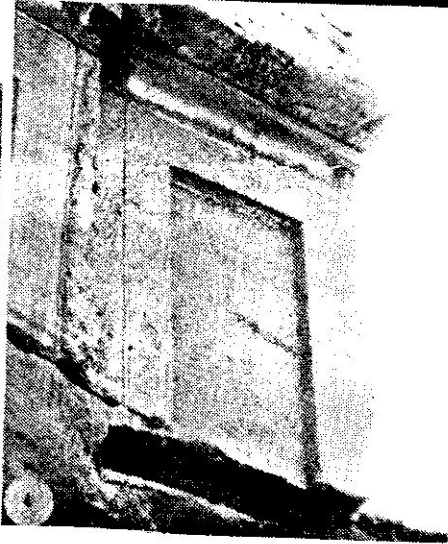
Pl. 7

Fig. (1) : Shows blistering of surface of stone due to chemical weathering.

Fig. (2) : Shows the serious effects of physio-chemical reaction in rock-cut chapel which resulting in a serious cracking of stones.

Fig. (3) : Shows the cracks in the Upper Parts of the Shrine and blistering of surface of stone as a result of weathering process, eastern bank of Nile, Silsilah.

Fig. (4) : Shows a aeriuous Damaging cracks in the bottom of Shashank Rock-cut Chapel as result of weathering effect.

traces of decoration remain (Pl. 7, Fig. 2). Local erosion caused by the mechanical effect of water flow during the flood of the Nile river which covers this path and flows along the cliff. A detachment of façades caused by water erosion.

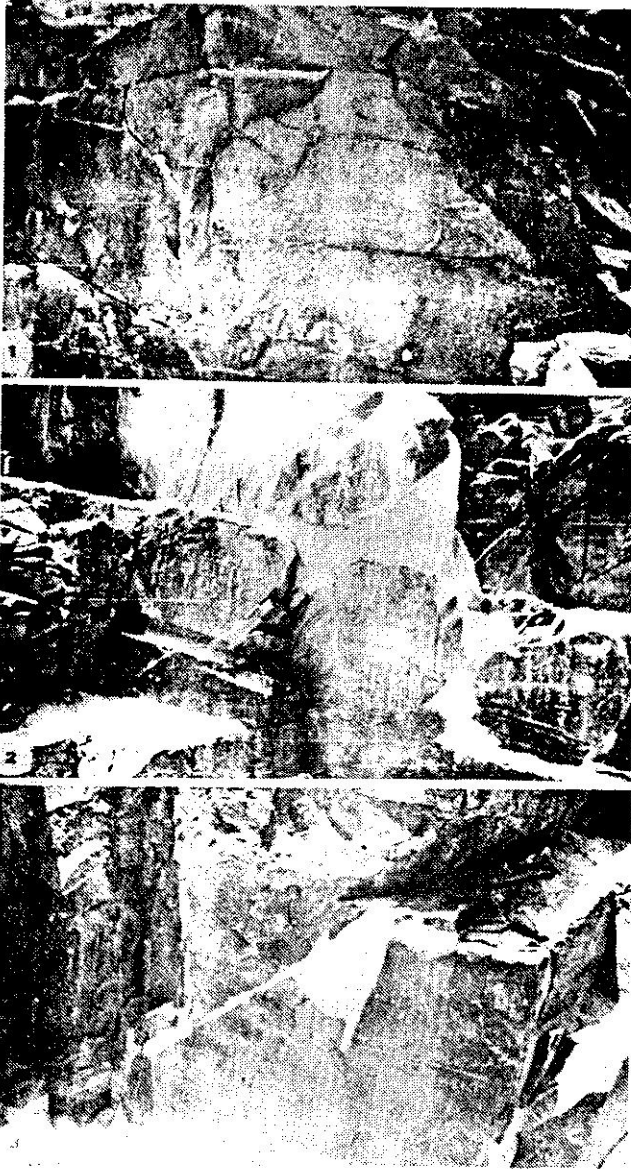
Pl. 13

Fig. (1) : Irregular cracks with changes in the color of rock art in the inscriptions of Xerxes I, 27th Dyn. This changes are due to the physiochemical weathering.

Fig. (2) : Predominately three sets of joints. This intersection leads to the blocks appearance of the out-crops. This geotechnical collapse could cause the fallen of the blocks which have the inscription of Pepi VI.

Fig. (3) : Detachment and deterioration of inscriptions of Pepi VI due to the intersection of three joints planes and the cracks were filled with Portland Cement which has lost its cohesion with the stone and fallen off.

diagonal cracks between vertical joints which can lead to block separation (Pl. 10, Fig. 3). Irregular cracks with the changes in the color of rock art are due the physio-chemical weathering around the inscription of Xerxes I (Pl. 13, Fig. 1). The following physical characteristics were determined for Hammamat stone according to ISRM, 1981, standards tests :

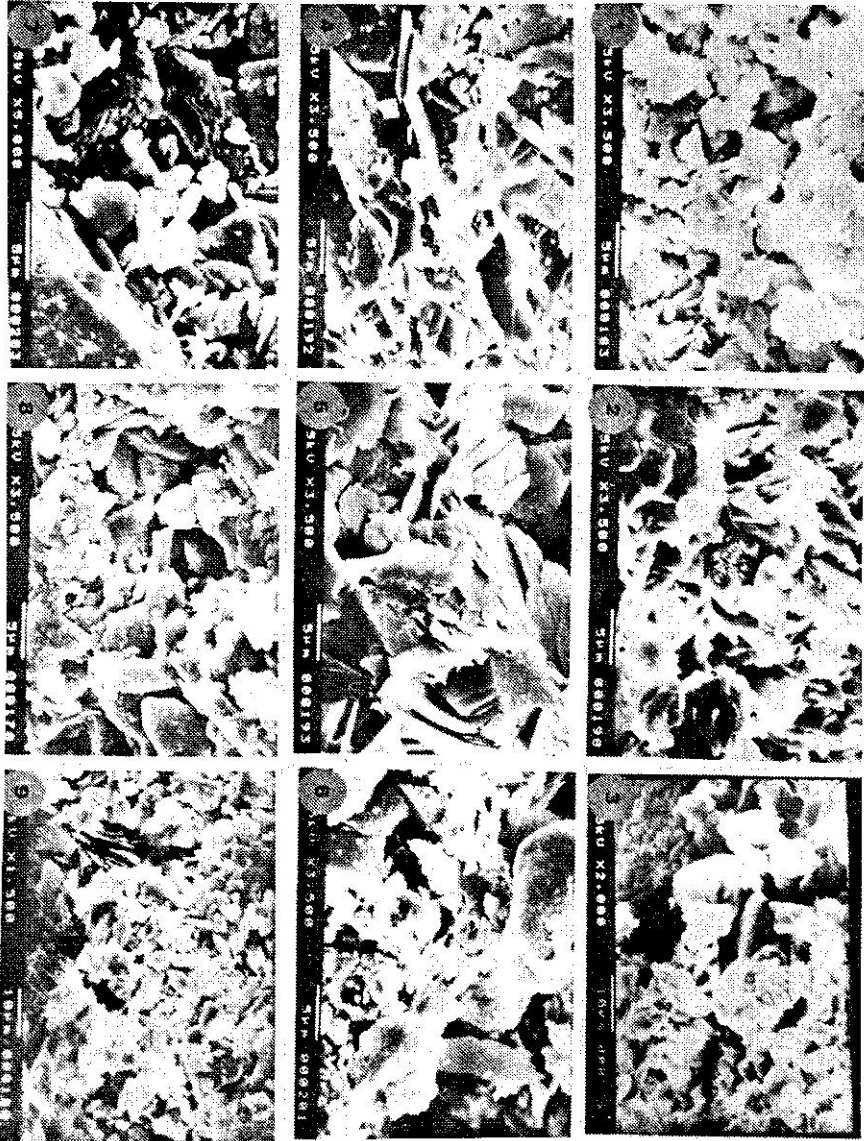
Pl. 15

Fig. (1) : Destroying of Quartz grains.

Fig. (3) : Deterioration of Hammamat stone due to the collapse of Quartz and Calcite minerals.

Fig. (4) : Cracks and fissures in the internal structure of Hammamat stone due to physical weathing.

Fig. (8) : Partial alterations in Feldspars minerals with the destruction of clay minerals.

Fig. (9) : The collapse of the internal structure of stone with traces of clay minerals

Physical deterioration in the mineral constituents of stone with different fractures inside the stone (Pl. 15, Fig. 4). Micrograph (Pl. 15, Figs. 7, 9) show the alteration of feldspars to clay minerals due to chemical changes. The leaching of calcite in a large extent of alterations as a function of the deterioration of greywacke. Micrograph (Pl. 15, Fig. 6) show the destroying of calcite crystals in different forms. The partial alterations in feldspars minerals are also observed (Pl. 14, Fig. 9) (Pl. 15, Fig. 8). SEM provided that clay minerals are found in all samples.
