Durability Characteristics of Some Diorite and Granodiorite Monumental

B.M. Ismaiel* & G.H. El-Habaak**

Abstract

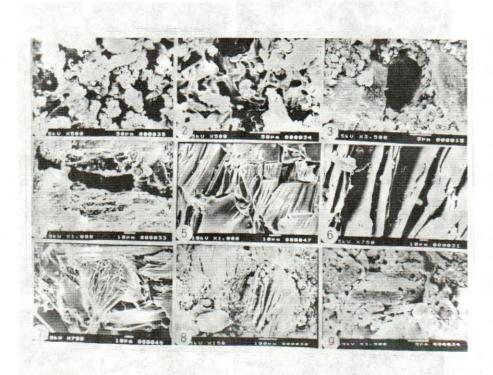
Plate 6: SEM micrographs showing: Fig. (1): The nature of deterioration inside the granodiorite samples, Fig. (2): The expansive mechanism due to the pressure exerted by the prismatic crystals, Fig. (3): Interpartical porosity, Fig. (4): Sub microfractures dissected plagioclase plate parallel to the twin planes, Fig. (5, 6): Plate pore in biotite, Fig. (7): Efflorescence of crystalline salts in holes inside the biotite, Fig. (8): Fall of lamellar fragments, Fig. (9): Micropits in plagioclase crystals.

The increase of porosity is due chiefly to the great density of pores in micropores and microfissures disseminated all around the stone, predominantly in feldspar grains and nearly observed by optical and scanning electron microscope (Pl. 6, Fig. 1-3).

The inherent weakness planes of the constituents minerals also affect the deterioration of the statues. Petrographical studies and scanning electron microscopy demonstrate that both the twin planes of the feldspars and (0001) cleavage planes of biotite are affected by the natural weathering and cause expansion in the surface of these weakness planes (Pl. 6, Fig. 4-6). This also assists in the alteration

Pittings are also present on the studied monuments. They are also observed in both the vertical and horizontal surfaces. The diameters and depths of these pits vary from macroscopic to microscopic scales (Pl. 6, Fig. 9). Some microflora is present inside these pits (Pl. 7, Fig. 1). There is a positive correlation between both the diameter and the depth of these pits. Several authors believed that pitting is more commonly associated with the activity of microorganisms (Caneva et al., 1992). Besides the biodeterioration mechanism, a direct decay mechanism of

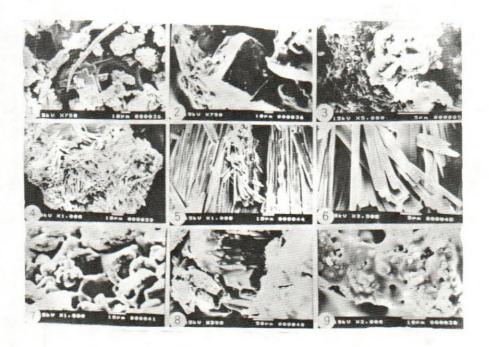
Plate 7: SEM micrographs showing: Fig. (1): Microflora inside the pits, Fig. (2): Cubes of common salt (halite), Fig. (3): Desert rose habit of gypsum crystals, Fig. (4-6): Concretion of crystalline gypsum plates and aciculate fibrous, Fig. (7): deteriorated sample treated with 20% B72 in Touline showing thin film of resin partially covering the large crystals and cavities of the stone, Fig. (8-9): deteriorated sample treatede with 10% B72 in Touline showing the resin covering the mineral grains and forms a fairly uniform and heavy coating on the stone particles.

Gypsum occurs as aciculate crystals growing perpendicular to the stone surface, as fibrous, plates (Pl. 7, Fig. 4-6), desert rose (Pl. 7, Fig. 3) or as irregular aggregates. Gypsum crystals are not restricted to the surface layers but are also distributed in the cavities and penetrate towards inside. Cubes of common salts (sodium chloride) are also observed (Fig. 2, Pl. 7). It is worth to mentioning that the high clay content produced through the weathering of feldspars accompanied by relatively large amounts of highly soluble salts, determined as sulfate, nitrate and chloride in addition to the enrichment of flaky minerals are considered as serious factors affected the studied statues.
